TECHNICAL REPORT  
NATICK/TR-85/026

# TRAY PACK IMPROVED DURABILITY PACKAGING ROUGH HANDLING TEST RESULTS

RICHARD D. CUMMINGS

UNITED STATES ARMY NATICK  
RESEARCH AND DEVELOPMENT CENTER  
NATICK, MASSACHUSETTS 01760-5000  
FOOD ENGINEERING LABORATORY

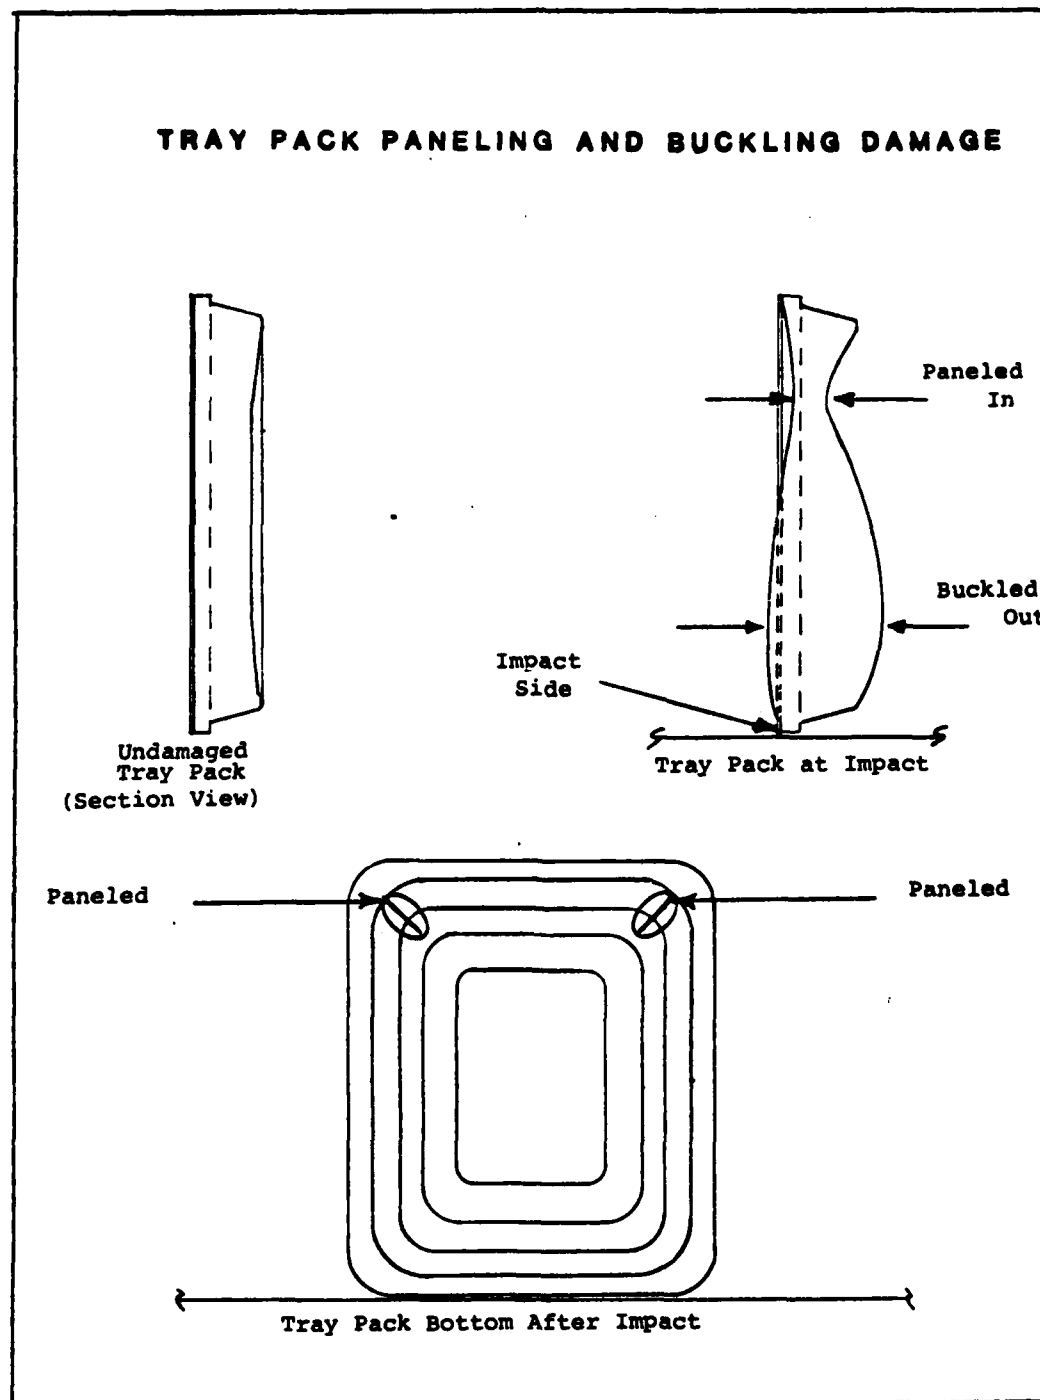
Buckling and paneling of the Tray Pack top and bottom are depicted in Figure 4. The causes of this damage are a combination of the vacuum in the container and the hydrodynamic forces generated by acceleration of the fluid (food) in the container. The vacuum in the container is generated during the food filling and sealing process and is a function of the type of food being packed and the amount of food packed in the container. The hydrodynamic forces generated by acceleration are caused by dropping and side impact of the Tray Pack during manual handling of the Tray Pack and during shipping and handling of Tray Packs in shipping containers and assembling into unit loads.

Buckling and paneling of the Tray Pack sides is caused by hydrodynamic forces within the Tray Pack when the Tray Pack is dropped on its bottom or its side. When the Tray Pack is dropped on its bottom, either inward paneling or outward buckling can occur, depending on the level of vacuum in the container and the amount of top and bottom reinforcement. When the Tray Pack is dropped on its side, outward buckling of the impact side can occur.

Figure 4. Tray Pack paneling and buckling damage

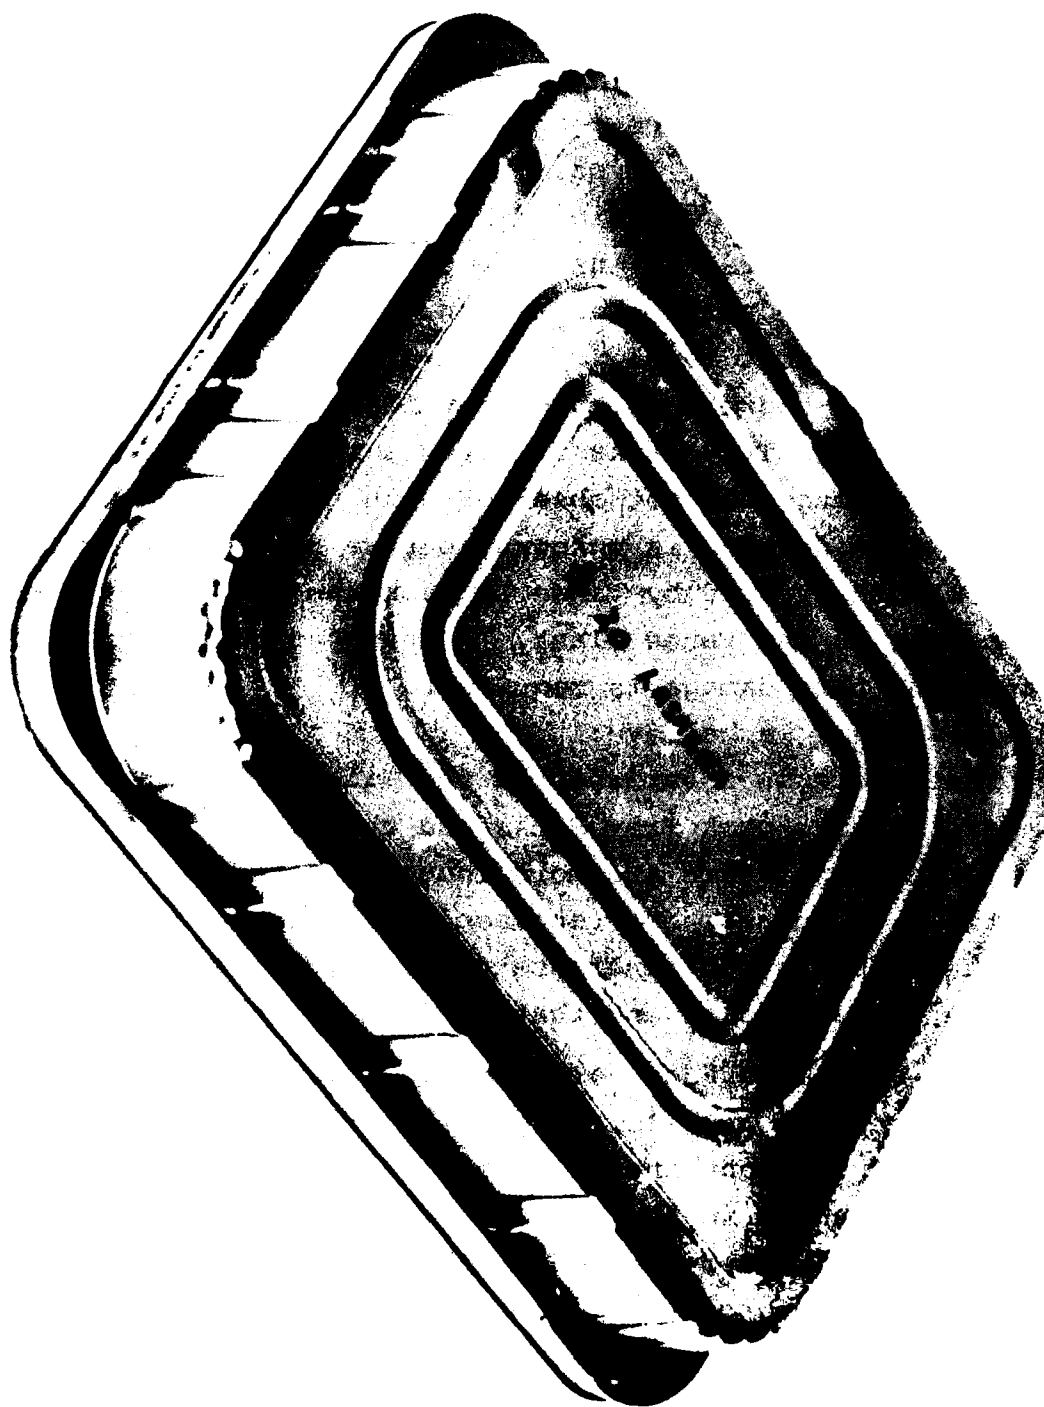
We are not exactly sure of the cause of Tray Pack denting. We do know that it is caused during the process of filling and handling in the food packer's plant and that it is caused by impact of the Tray Pack with some relatively pointed object or objects.

Figure 17. Tray Pack denting damage

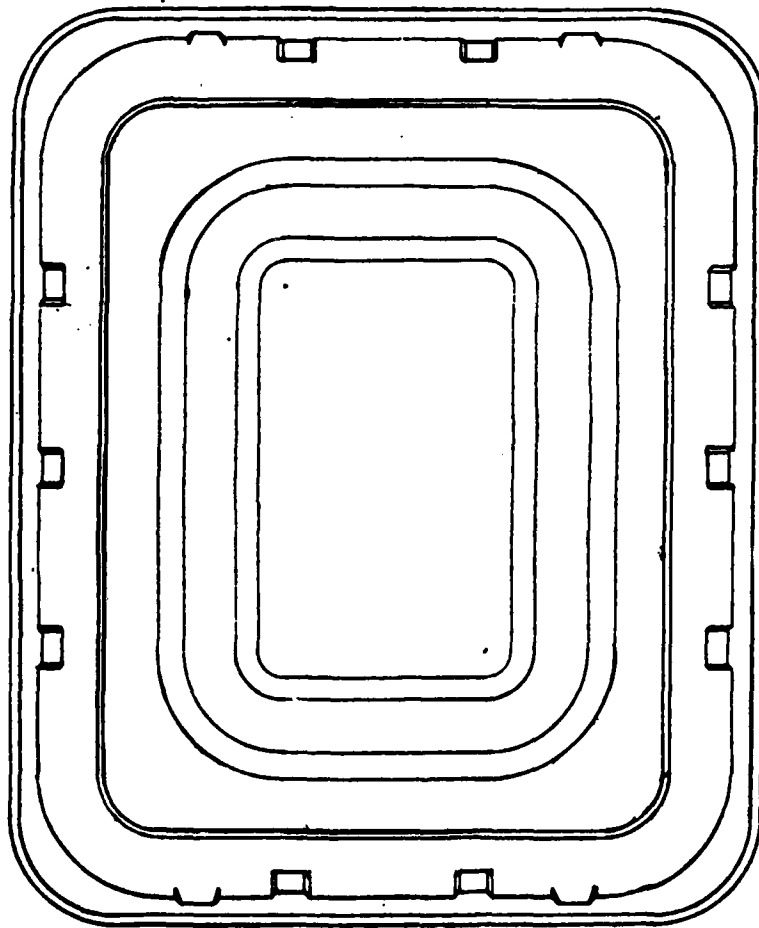
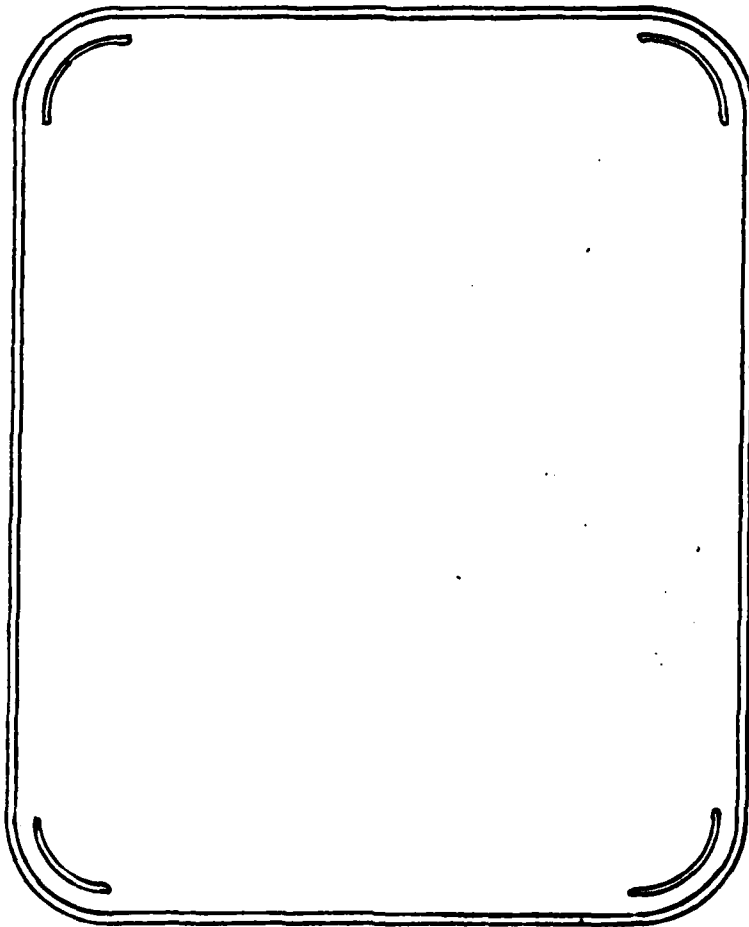
**BASELINE TRAY PACK**

TRAY PACK CONCEPT	VACUUM LEVEL	FAILURE TYPE
BASELINE	2.5" HG	DEEP INDENT PANELS DIAGONALLY OPPOSITE CORNERS
CROSS REINFORCED AT BOTTOM	2.5" HG	REINFORCEMENT SUPPORTS BROKE FREE
BOTTOM REINFORCED ACROSS WIDTH TO WITHIN 3/9" OF EDGE	3.31" HG	VERY CONTROLLED PANEL
TOP AND BOTTOM REINFORCED ACROSS WIDTH TO EDGE	4.12" HG	SINGLE SLIGHT CORNER PANEL VERY CONTROLLED

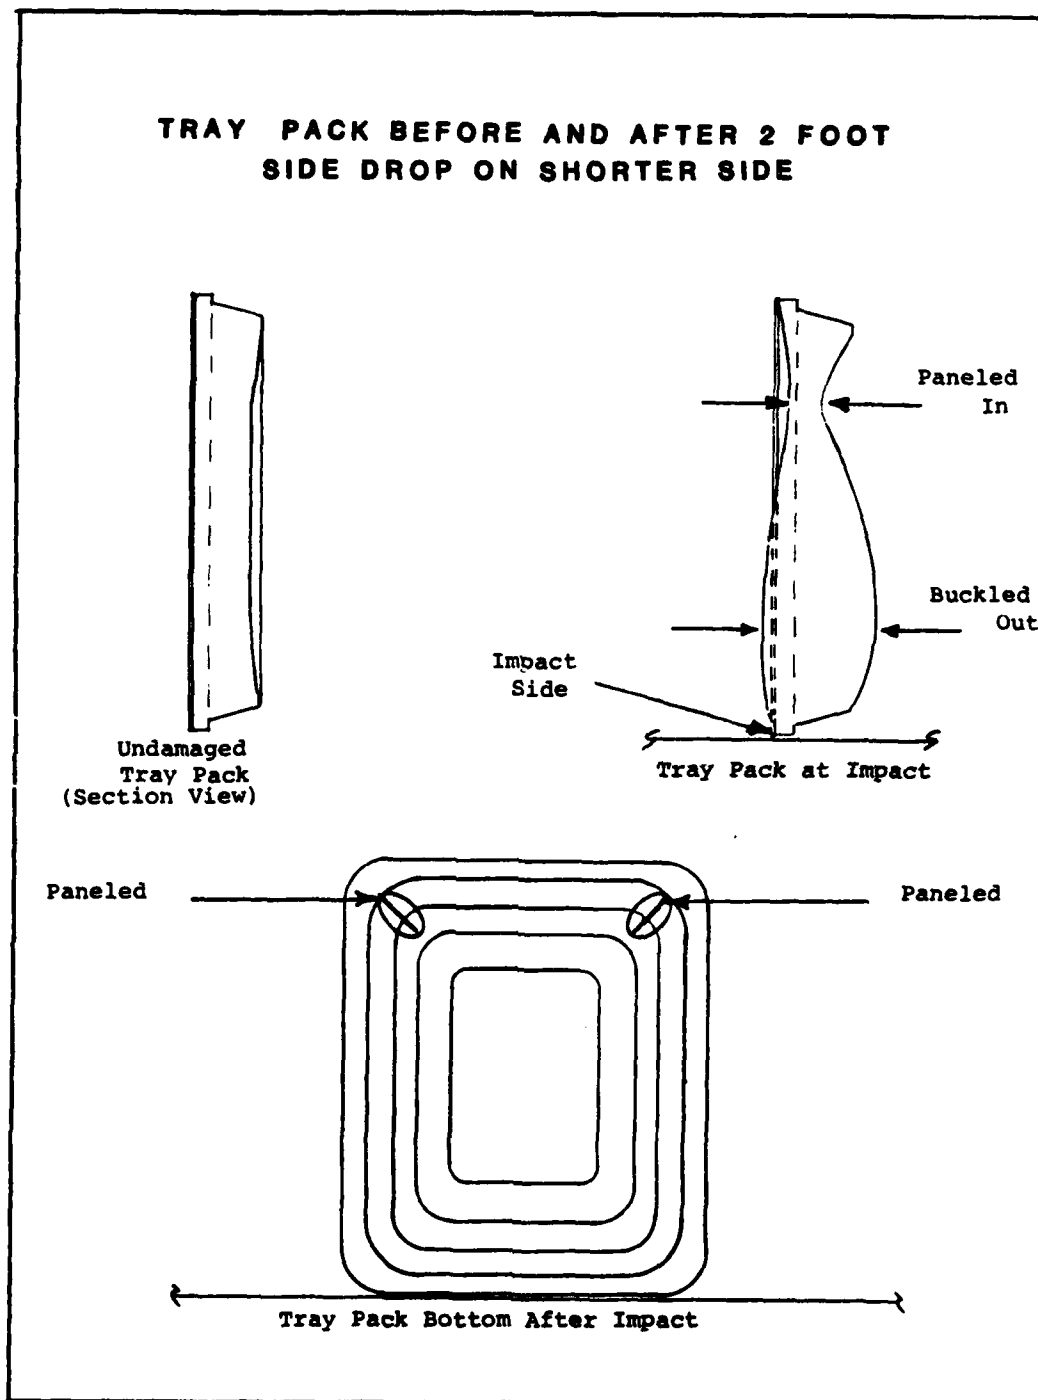
**Figure 22. Tray Pack before and after 2-foot  
side drop on shorter side**

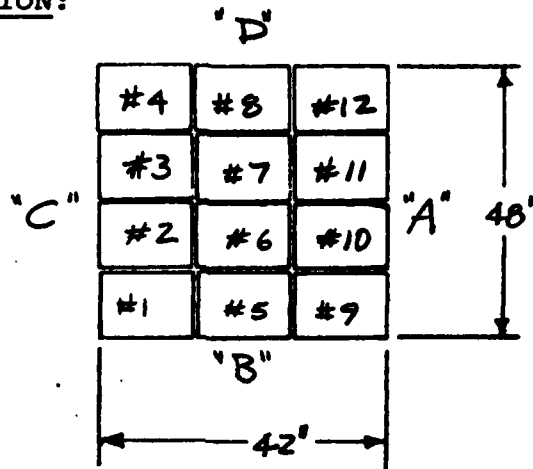
UNIT LOAD TYPE: BASELINE

EDGE	OBSERVATIONS
6" DROP EDGE "A"	FIRST LAYER CARTONS (#19, 110, 111, 112) SIDES BUCKLED AT DROP EDGE. WHOLE STACK SHIFTED, TOP LAYER 3/4", THIRD LAYER 1/2" OPPOSITE DROP END, SECOND LAYER 1" AT DROP END.
6" DROP EDGE "C"	FIRST LAYER CARTONS (#11, 12, 13, 14) SIDES BUCKLED AT DROP EDGE. SECOND LAYER SHIFTED TOWARDS DROP EDGE, 1 3/4" AT "B" END AND 1" AT "D" END. SECOND (1") AND THIRD LAYERS SEPARATING IN THE CENTER "C" SIDE (1/2") SUCH THAT FIRST LAYER OVERHUNG BOTH ENDS.
6" DROP EDGE "B"	NO BOXES BUCKLED, SLIGHT SHIFT (1/4" MAX) OF ENTIRE LOAD TO DROP END.
6" DROP EDGE "D"	1) SAME DROP HEIGHT BUT RESULTANT ANGLE LESS. 2) "A" END FIRST LAYER CARTON #112 STARTING TO BUCKLE. 3) SHOCK LESS SEVERE AS CARTONS UNDERHANG PALLET BY 2".

TRAY PACK DAMAGE FOUND DURING POST TEST INSPECTION - NONE

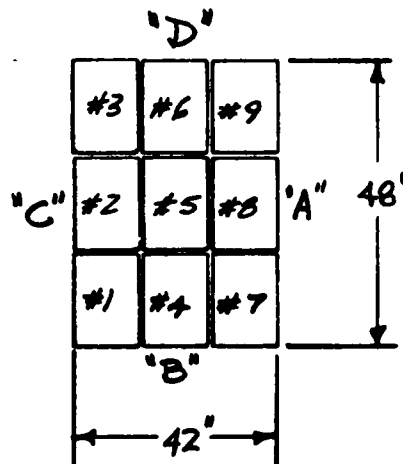
UNIT LOAD TYPE: BUNDLE CONCEPT

EDGE	OBSERVATIONS
6" DROP EDGE "A"	NO CHANGE OBSERVED.
6" DROP EDGE "C"	NO CHANGE OBSERVED.
6" DROP EDGE "D"	BOTTOM TIER END CARTONS 3 AND 9 SHORT FACES BUCKLED. CENTER CARTON #6 O.K. NO OTHER CHANGES OBSERVED.
6" DROP EDGE "B"	NO CHANGE OBSERVED.

TRAY PACK DAMAGE FOUND DURING POST TEST INSPECTION - NONE
